Testing and Analysis of an Alternative Connection Method in Closed Panel Timber Frame Domestic Construction

Mphil Thesis

DIT School of Construction

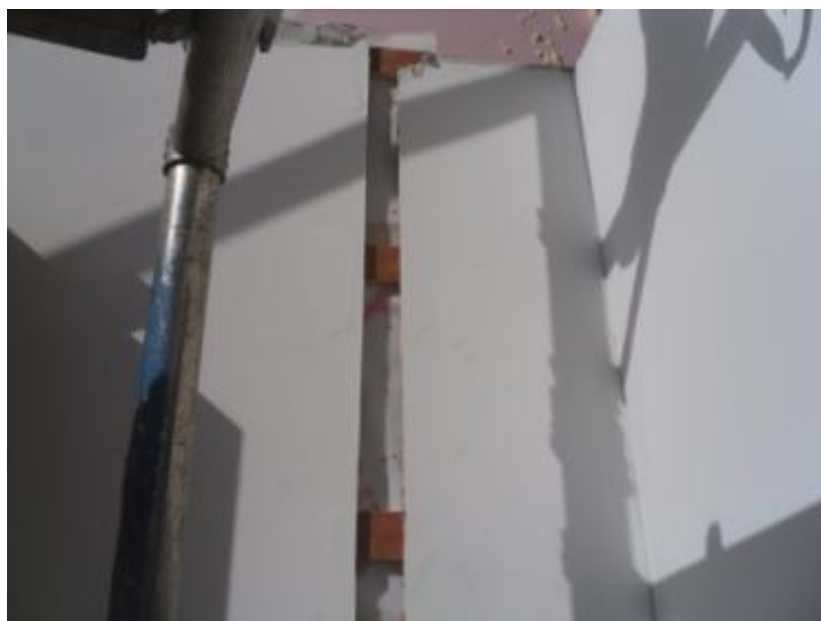
Figure 52: Joint between the 100mm wall panels after positioning

Rather than fix both the Sherpa™ connectors and Compriband tape to every wall panel, it was decided to use one Sherpa™ for the first wall connection and build up with the possibility of using two if they proved successful. The Compriband tape could then be used at this point to determine its suitability for the project. Smaller ‘L’ shaped brackets were also to be used at the base of every wall panel in order to provide a solid connection. The first use of the Sherpa™ connectors was in the joining together of two 100mm thick closed panels. Only one Sherpa™ connector was used close to the top of the wall. Using only one allowed for proper alignment of the wall and more space in terms of dropping the wall into position. The single connector acted like a guide-pin, aligning the two walls perfectly and with no connection issues (Refer to Figure 52).

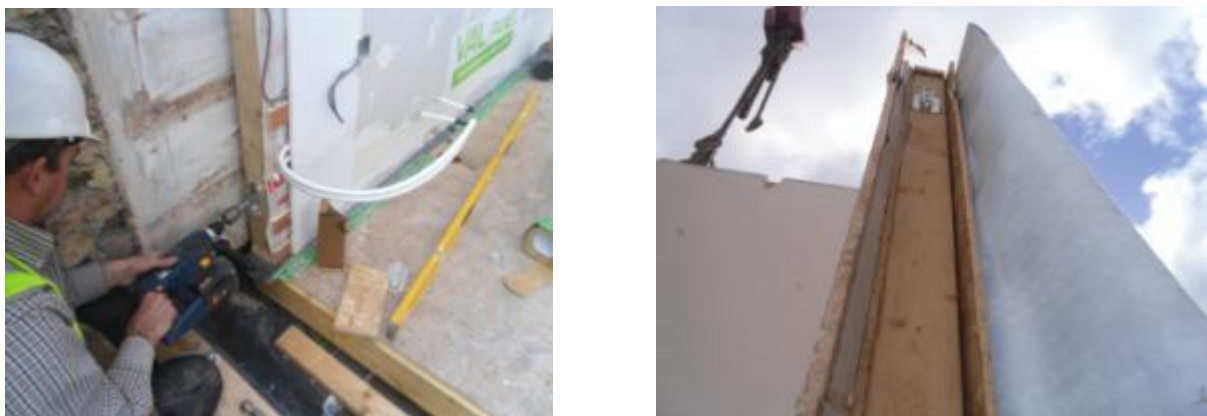
Figure 53: Application of SHERPA connectors to positioned wall

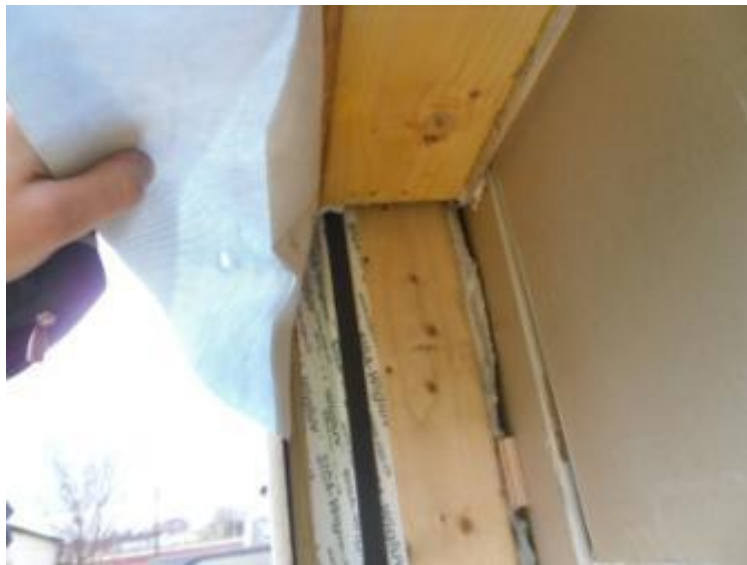
Figure 54: Image of final panel sliding into position (Compriband tape visible)

The next assessment of the connection system was to position the final wall of the structure (Figure 54). This would be the most difficult panel to drop into place as it was required to fit between two pre-positioned panels. In order to connect the panel properly, four Sherpa’s™

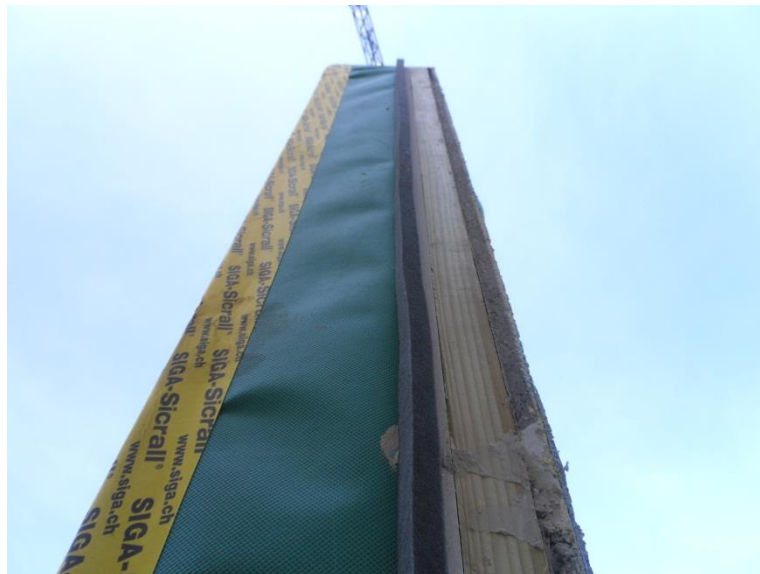
Figure 71: Image of end detail of Wall 1 before being positioned. The external breather membrane (green) is wrapped and taped on the inside of the wall (yellow) before the addition of the Compriband strip

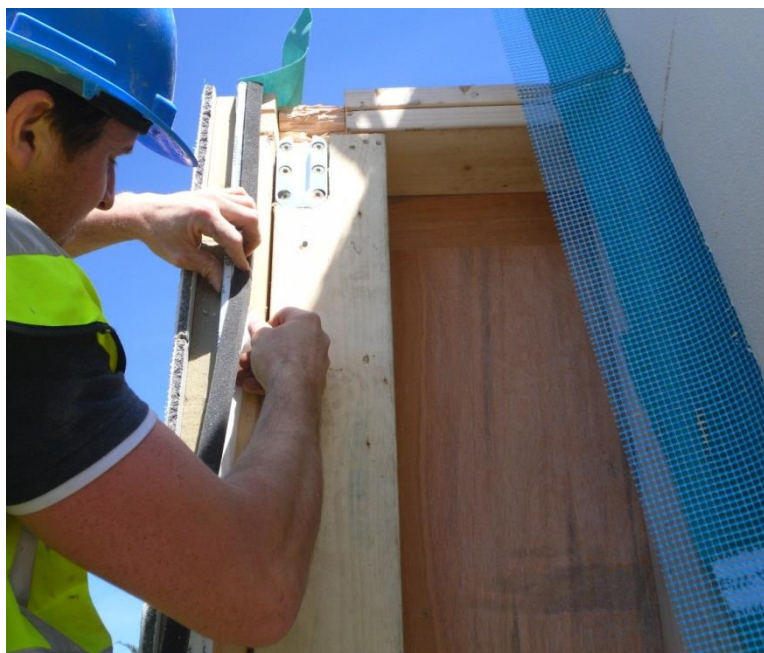
Figure 72: Installation of Compriband tape after the external breather membrane has been taped to the end stud

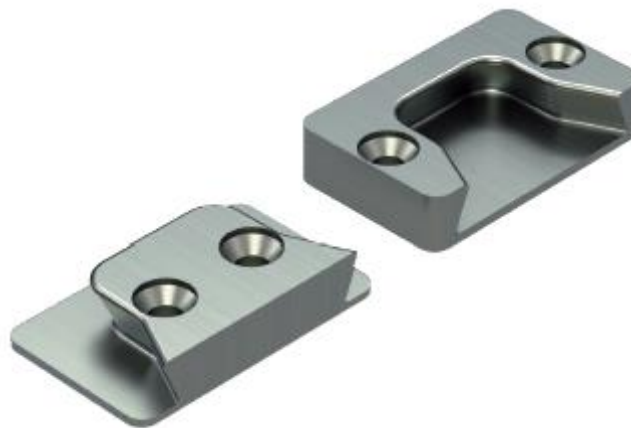
Figure 73: W8 connectors selected for re-development of connection detail

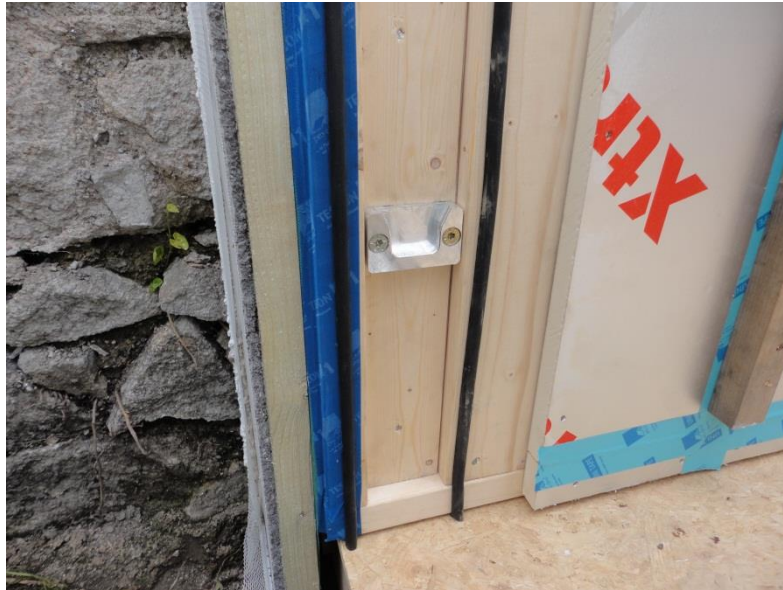
Figure 78: Bituminous layer with EPDM sealant between new and old building

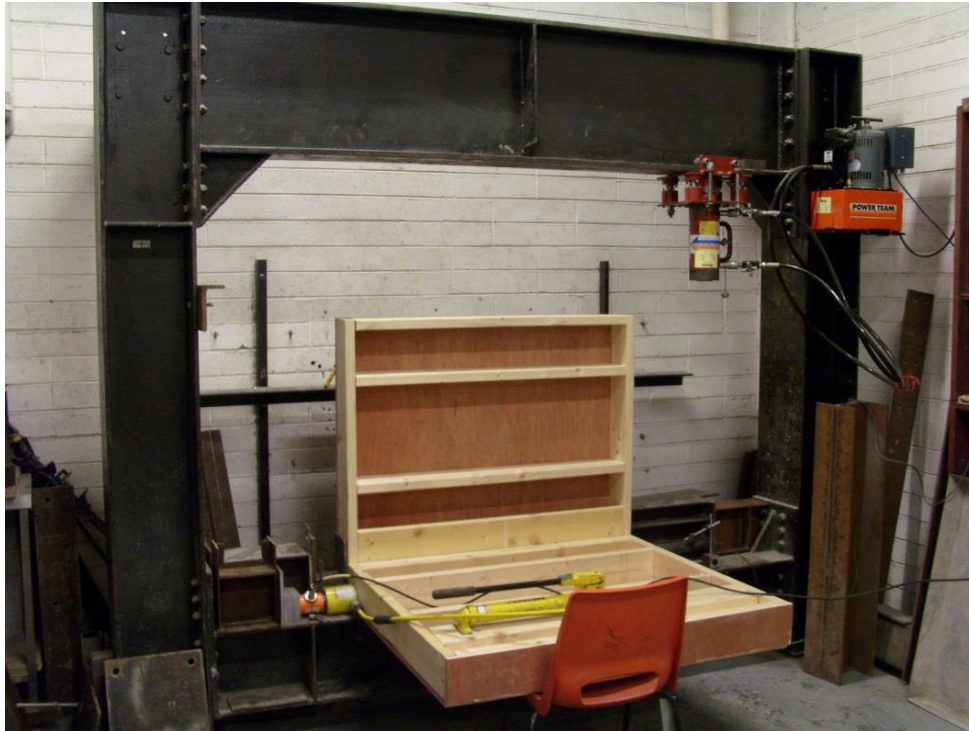
Figure 94: Steel framed testing rig

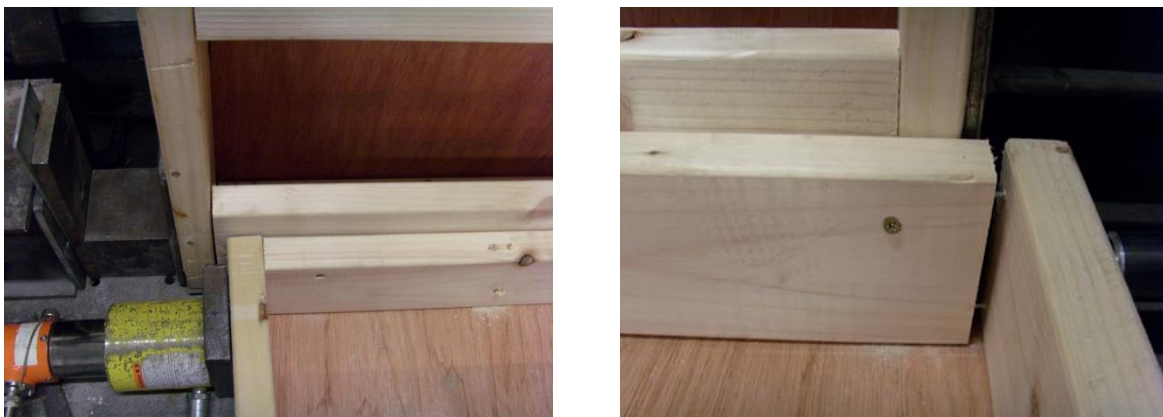
Figure 96: Images taken of test 1A after test completion

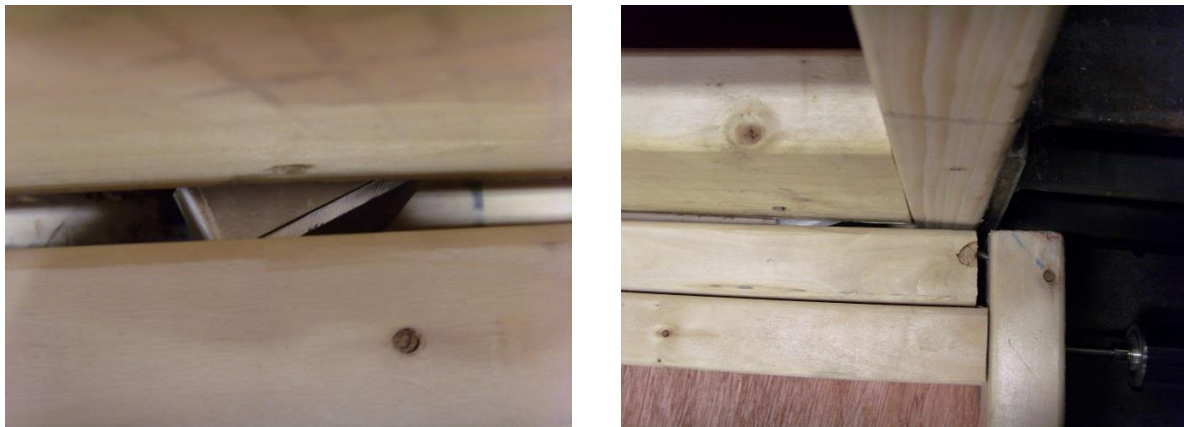
Figure 99: The left image shows pivoting Sherpa connector and the right image shows the range of movement of panel 'B' during test

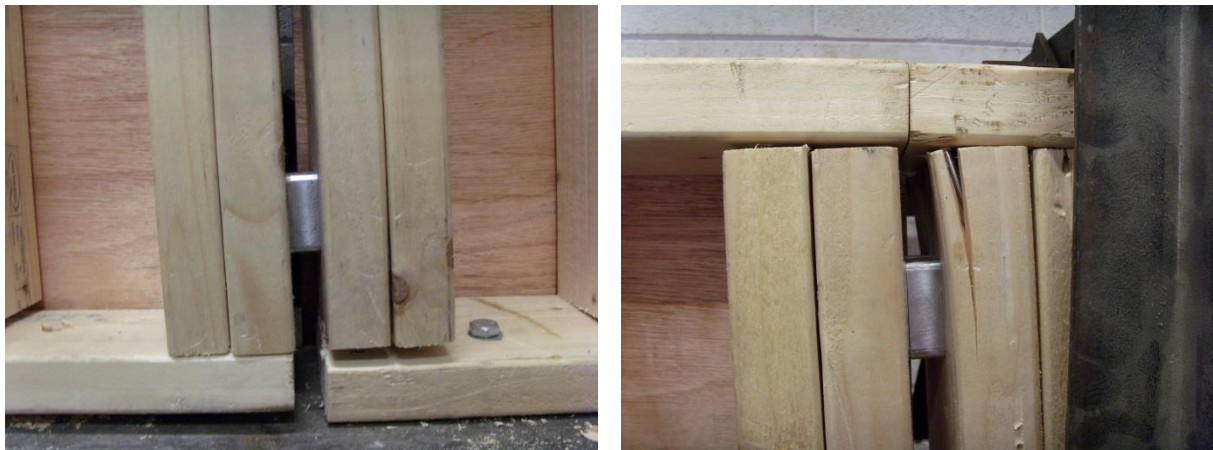
Figure 108: Images showing damage to test panels after the completion of Test 2B
